TruePosition Indoor Test Report Wilmington, DE

Appendix A: Performance Results Per Test Point

March 22, 2013

TechnoCom

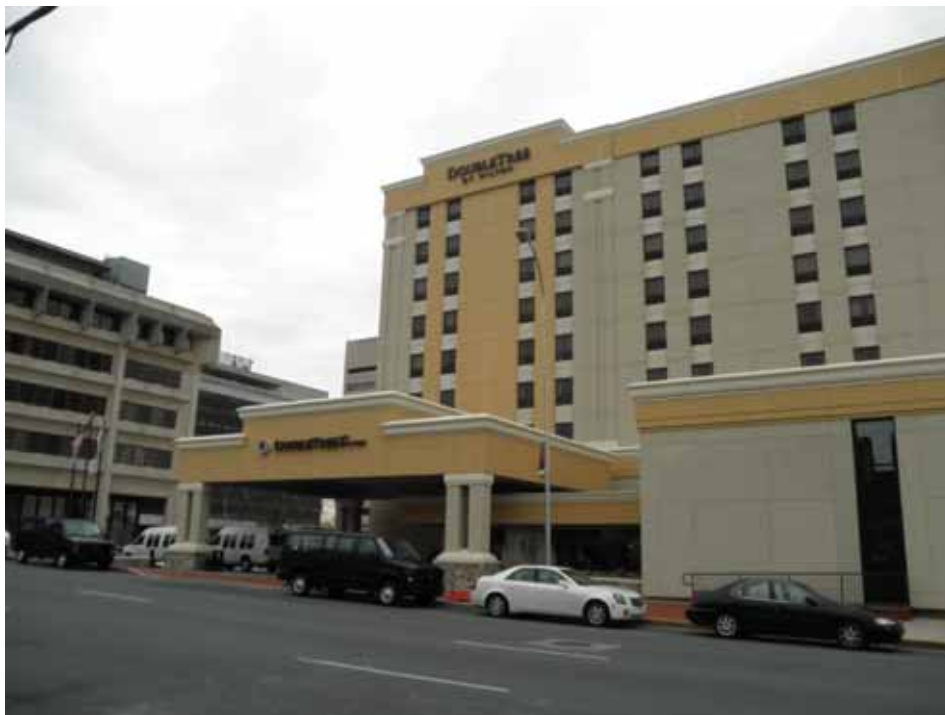
Building 3 is the DoubleTree Hotel located at 700 N. King Street, Wilmington, DE. It is a 9 story concrete and glass building with an attached two story structure to its east and an attached 3 story parking structure to its west. The other building in the background is the Wilmington courthouse across 8th Street.

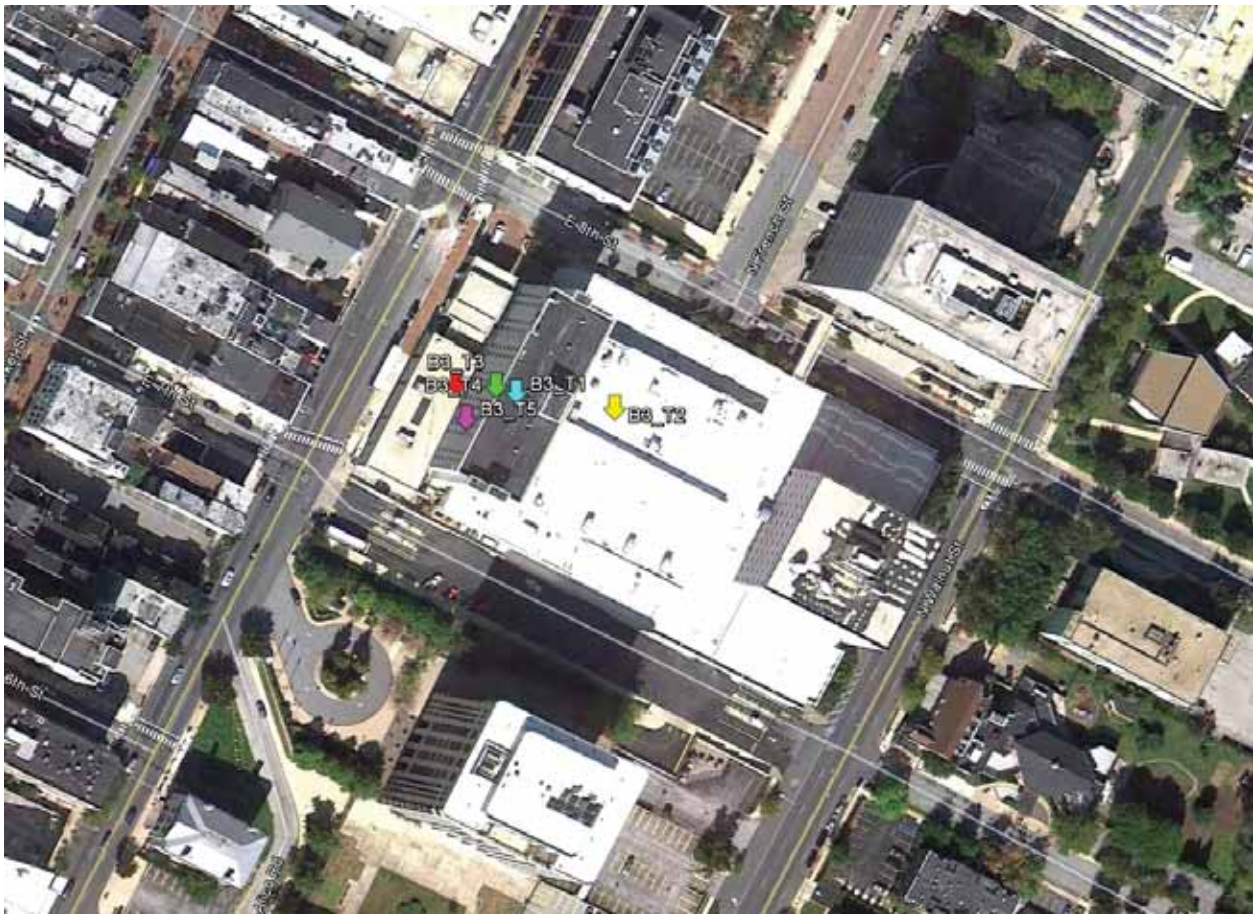
Building 3 is in the urban part of the City of Wilmington, and as seen in the Google Earth aerial view, it is surrounded by other buildings of varying heights in all directions.

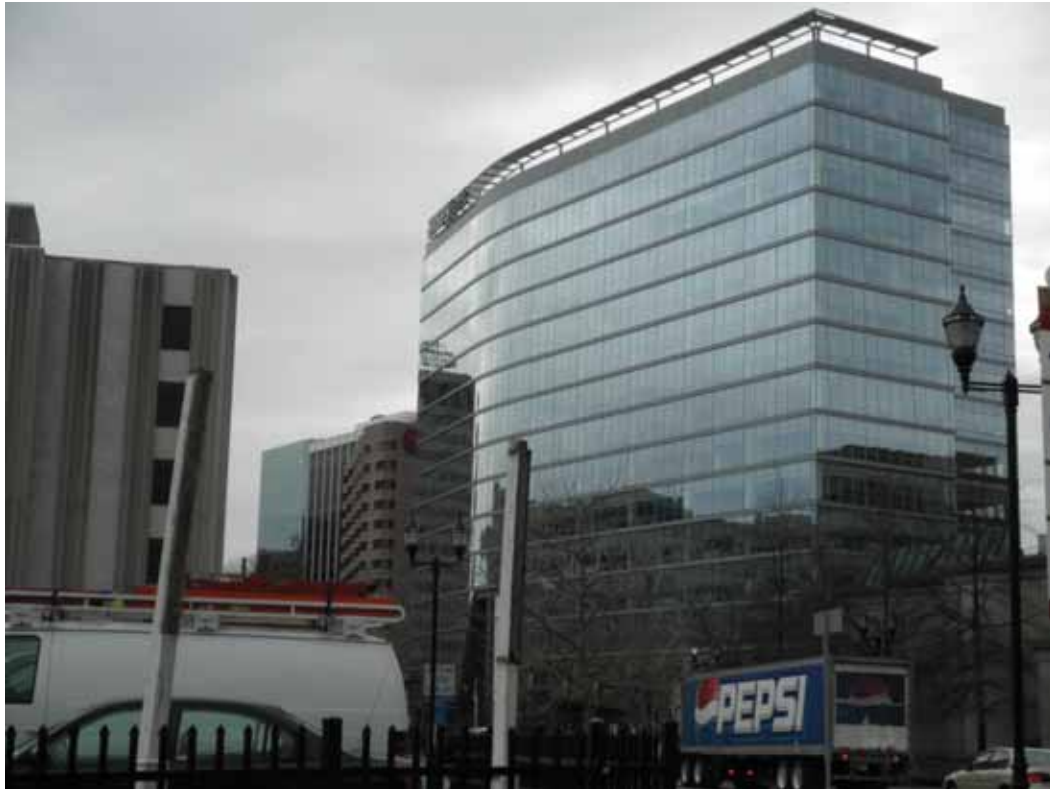
Building 5 known as “500 Delaware” building at 500 Delaware Ave., Wilmington, DE. It is a 15 story glass office building surrounded by other tall office buildings.

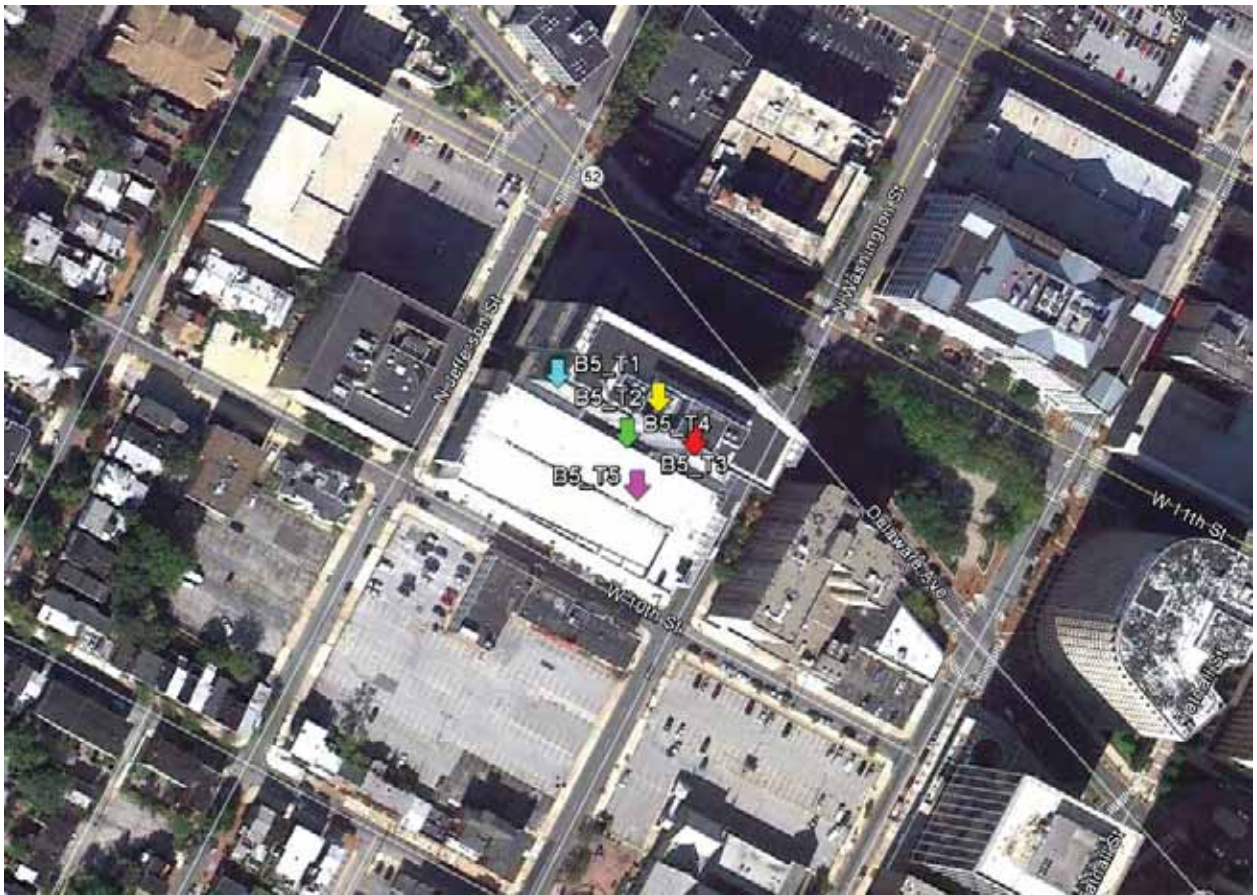
As seen in the Google Earth aerial view, Building 5 is in the core of the urban part of the City of Wilmington, surrounded by other large buildings in most directions.

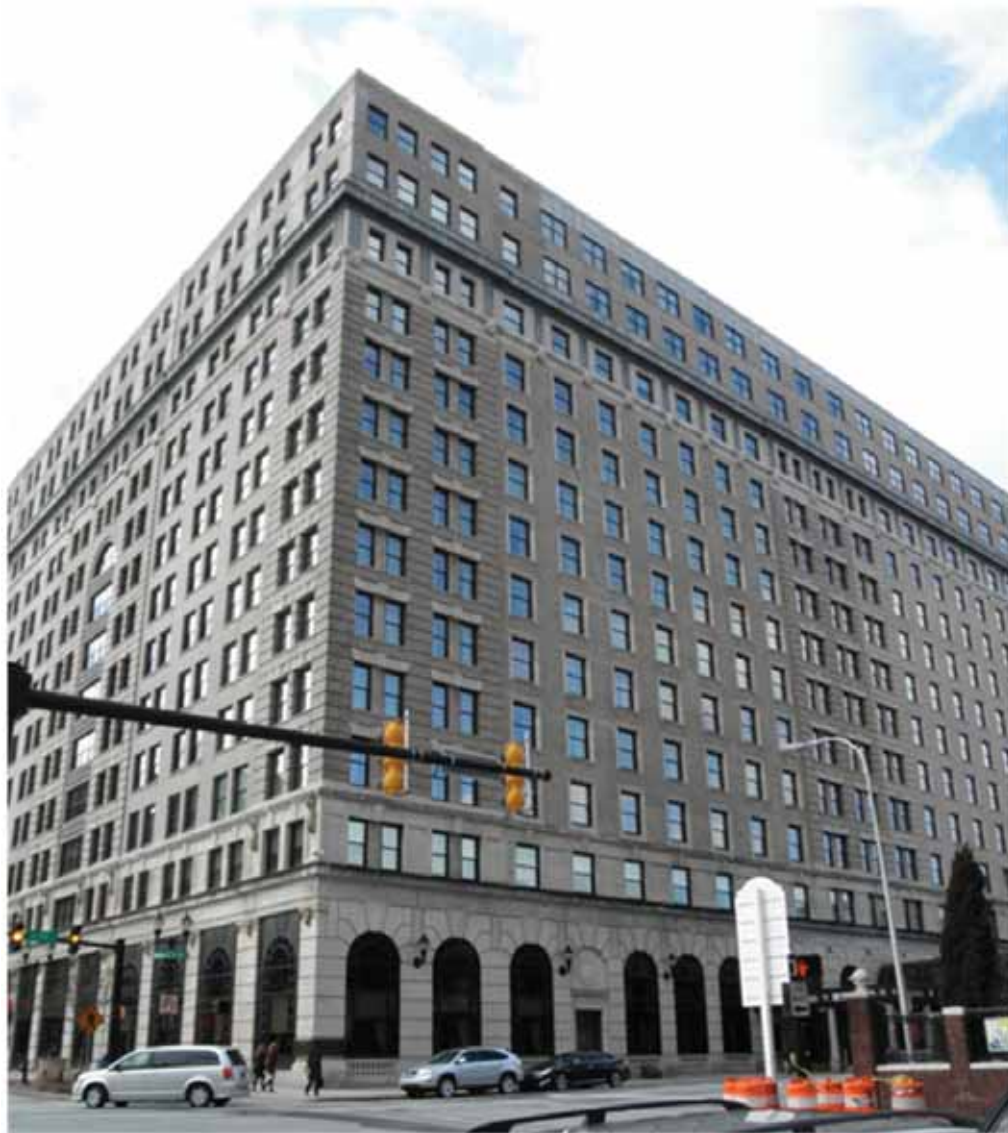
Building 6 is the “Nemours” building at 1007 N. Orange in Wilmington, DE. It is a 14 story concrete building covering a full street block. It is surrounded in all directions by office buildings and parking structures.

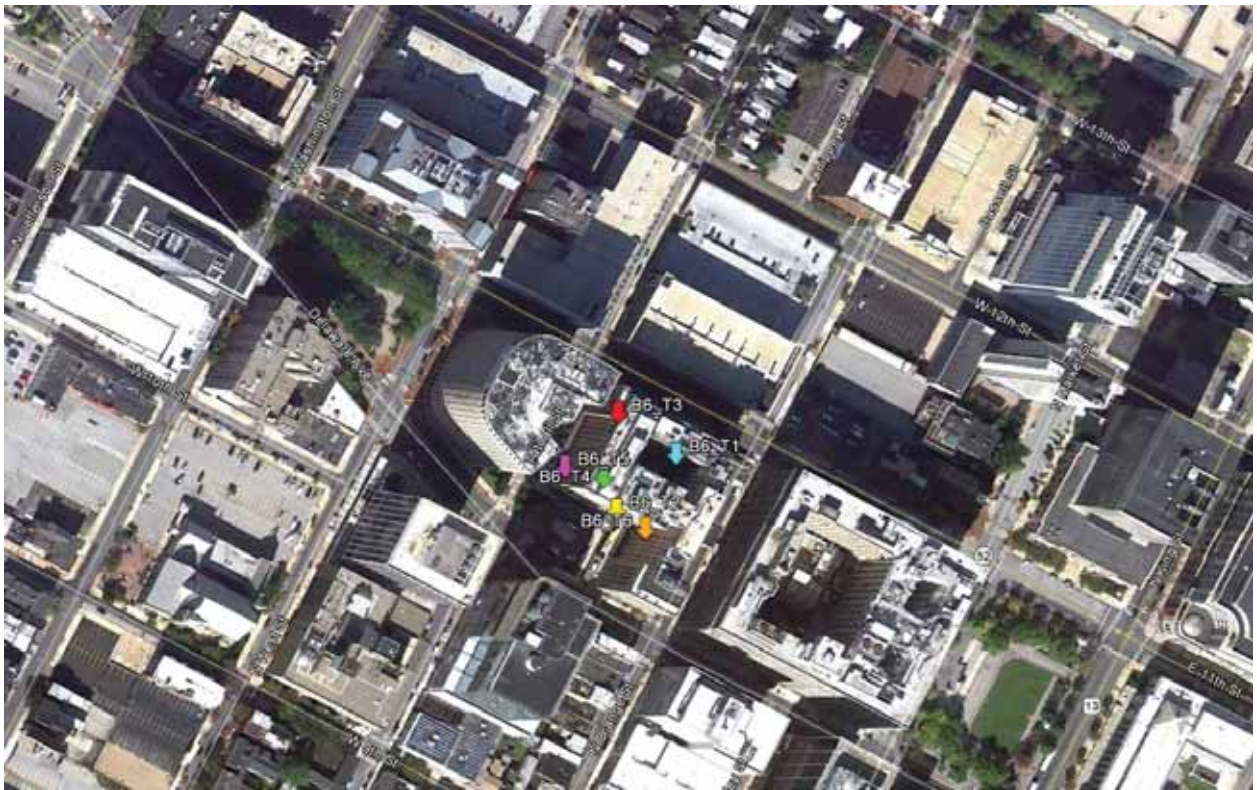
As seen in the Google Earth aerial view, Building 6 is in the core of the urban part of the City of Wilmington, surrounded by other large buildings in various directions.

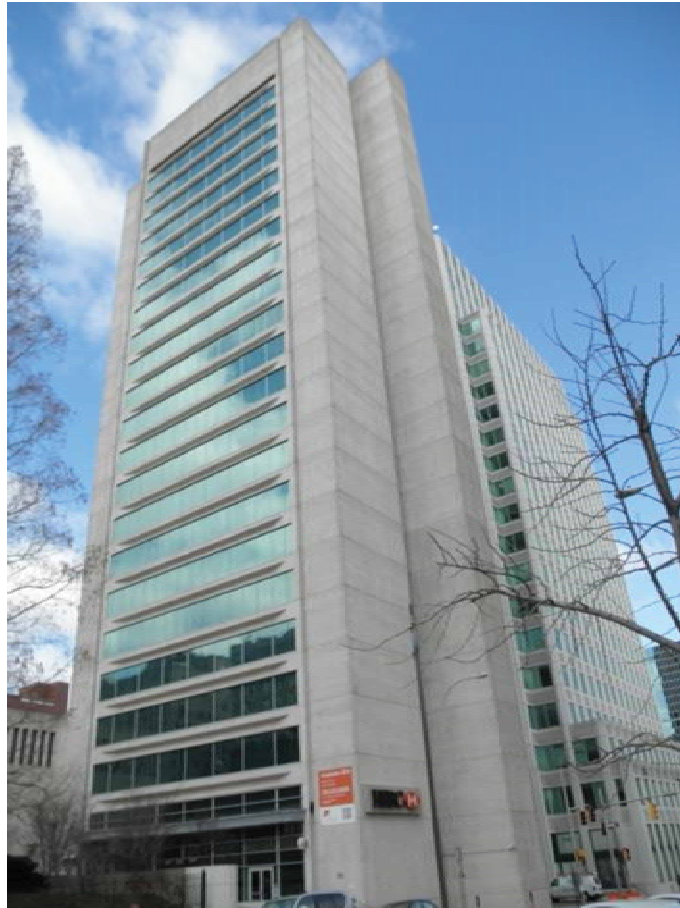
Building 7 is the “Wilmington tower” building at 1105 N. Market Street in Wilmington, DE. It is a 22 story concrete and glass office building. It is the building in the foreground shown below. (The other tall building in the background is across 12th Street.)

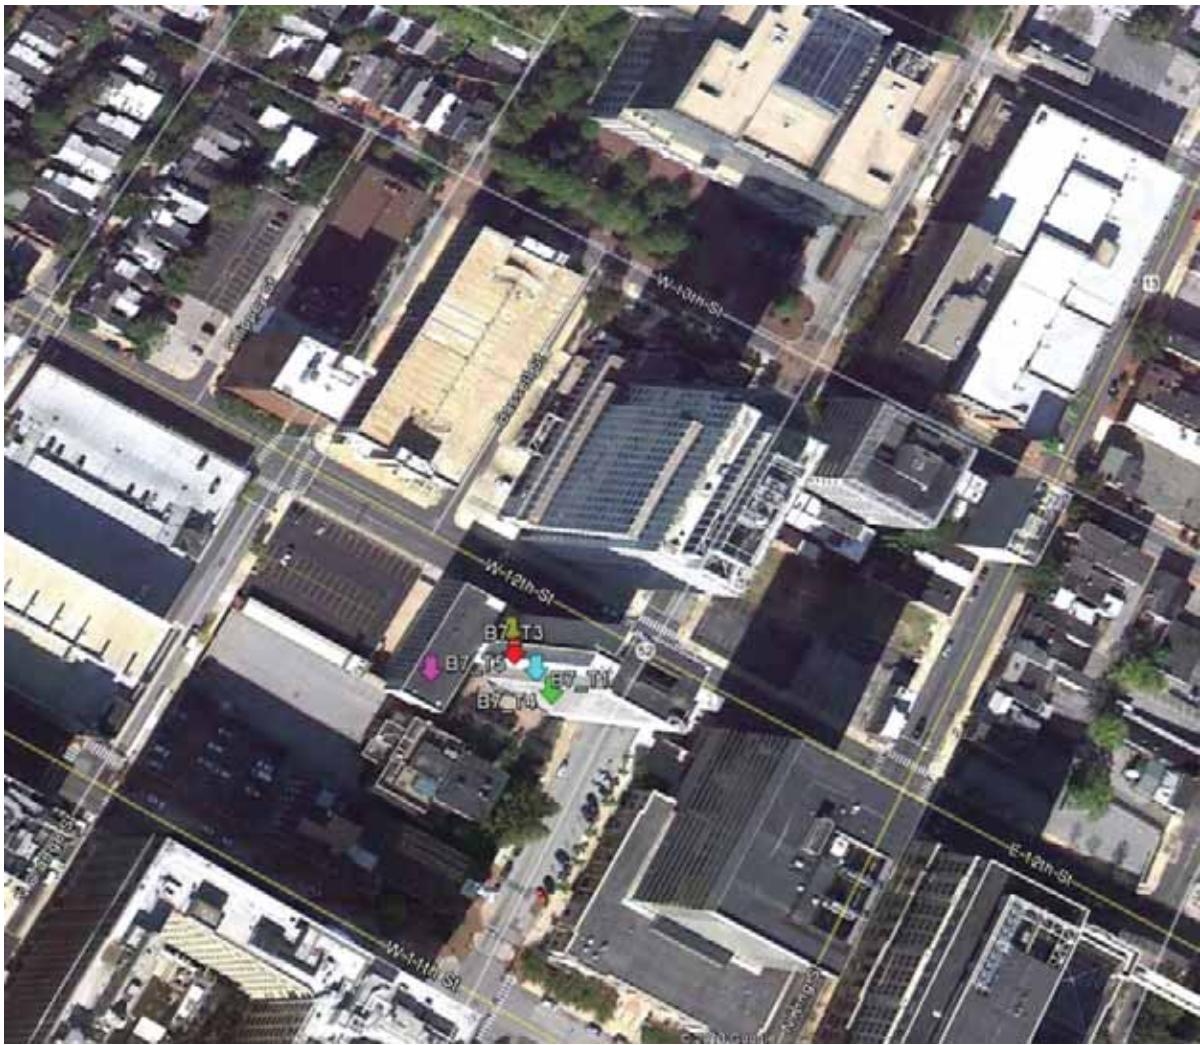
As seen in the Google Earth aerial view, Building 7 is in the core of the urban part of the City of Wilmington, surrounded by other large buildings in various directions.

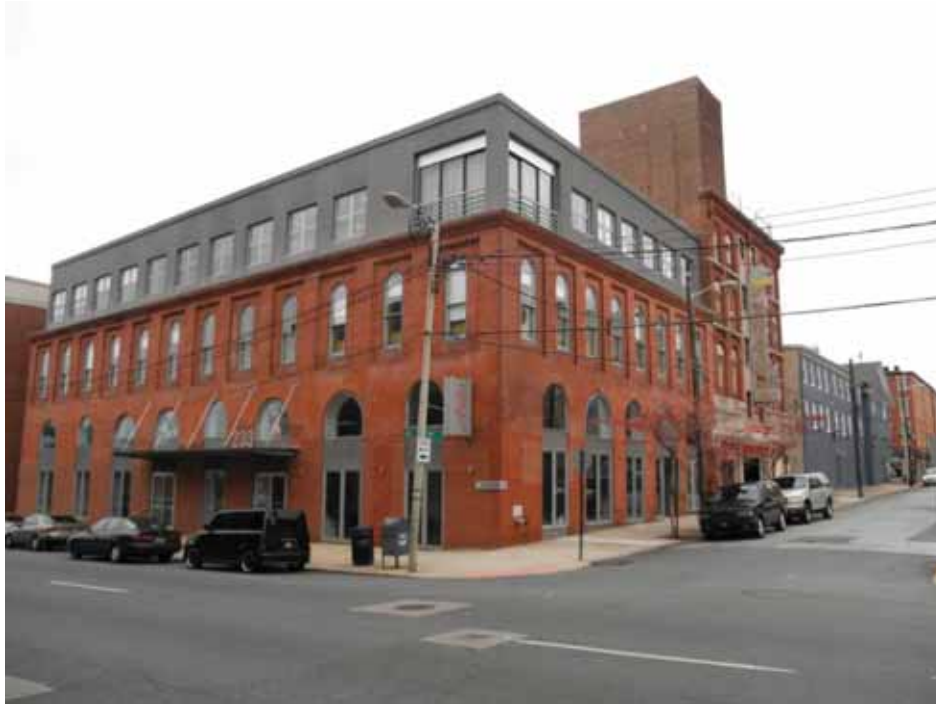
Building 9 is the “233 King St.” building at 233 N. King Street in Wilmington, DE. It is a 4 story brick corner office building attached in two sides by similar structures.

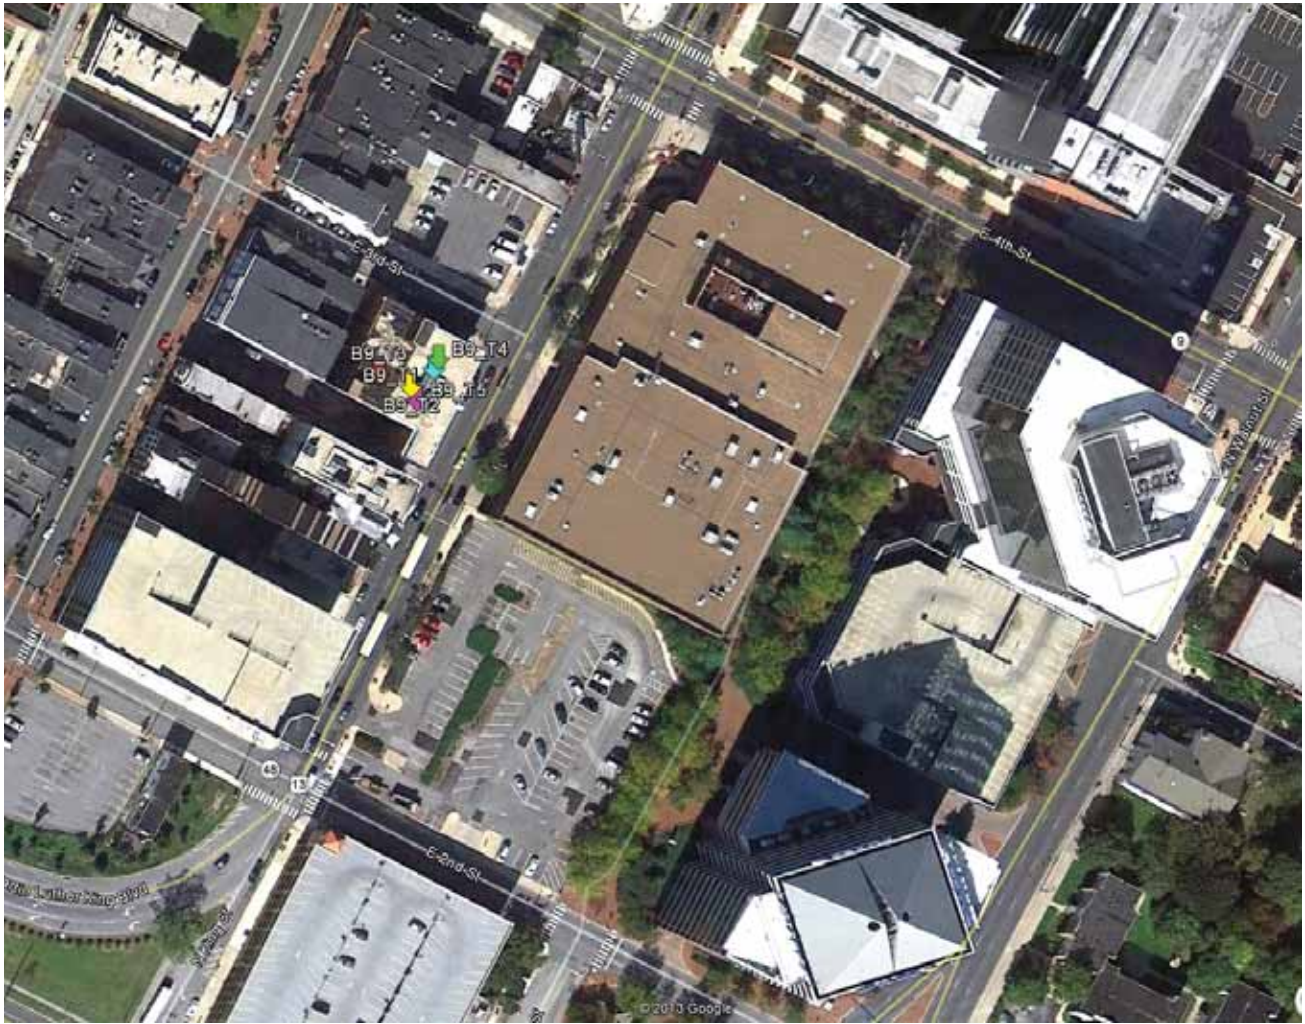
As seen in the Google Earth aerial view, Building 9 is in the somewhat lighter urban part of the City of Wilmington, surrounded by other similar sized buildings. However, not too far across the street, taller structures are seen. Those can play a key role affecting location system performance.

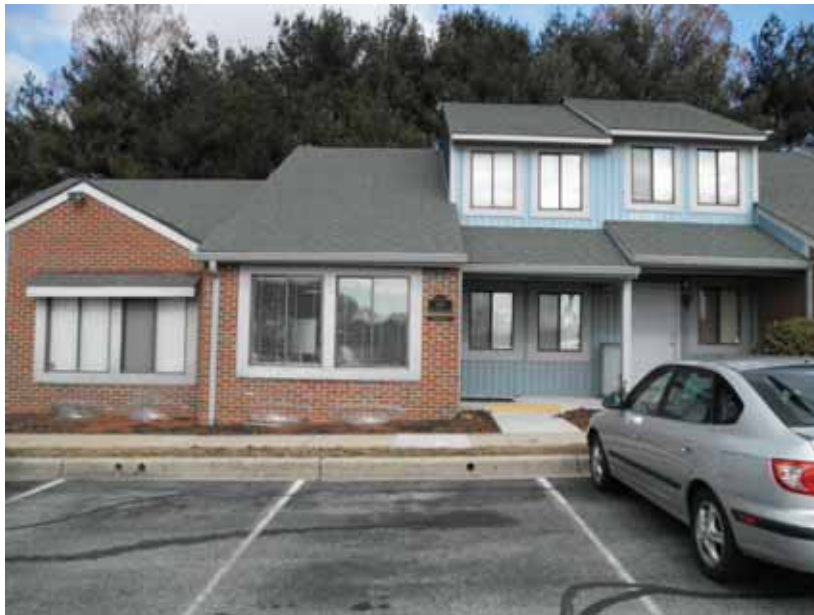
Building 1 is a two story townhouse converted to office space. It is located at 5215 W. Wood mill Drive, Suite 38, in Wilmington, DE.

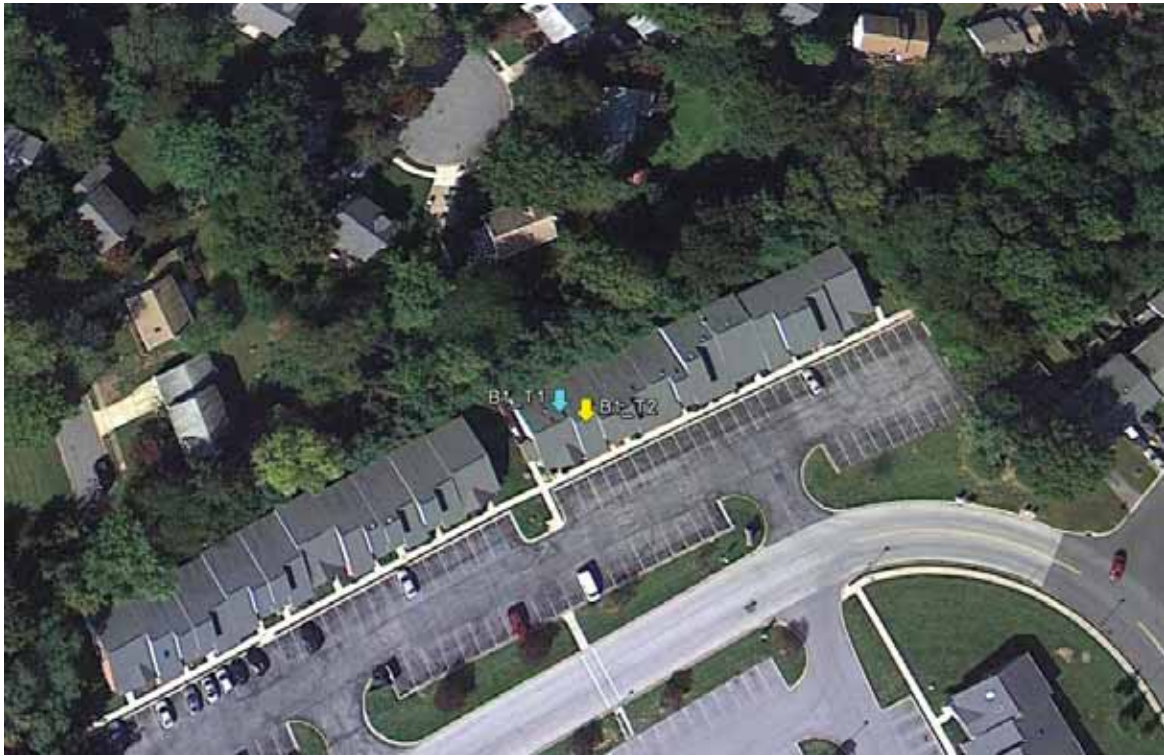
As seen in the Google Earth aerial view, Building 1 is in the suburban area of Wilmington neighboring townhouses and single family homes.

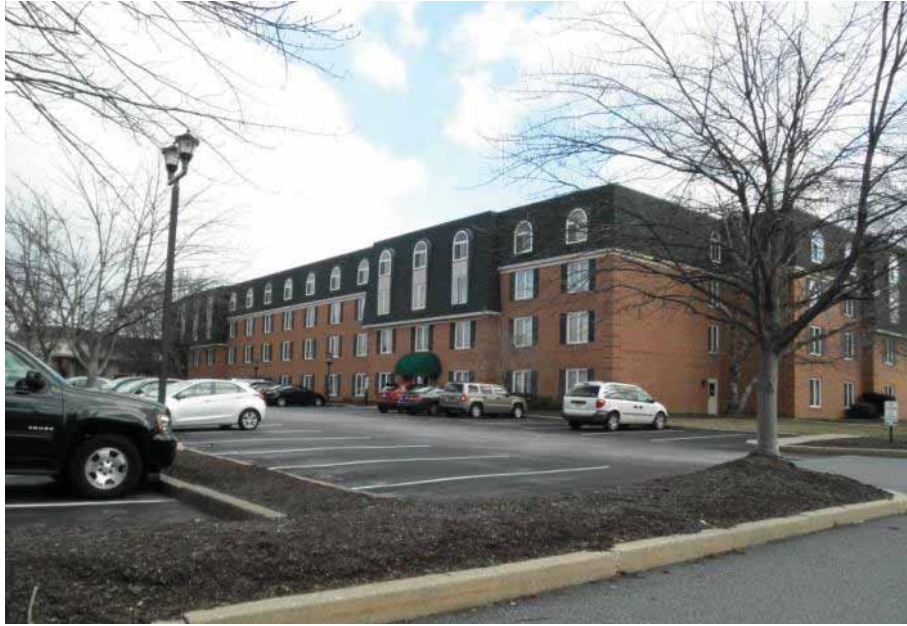
Building 2 is the Hilton Hotel located at 100 Continental Drive in Newark, DE. It is a 4 story brick building.

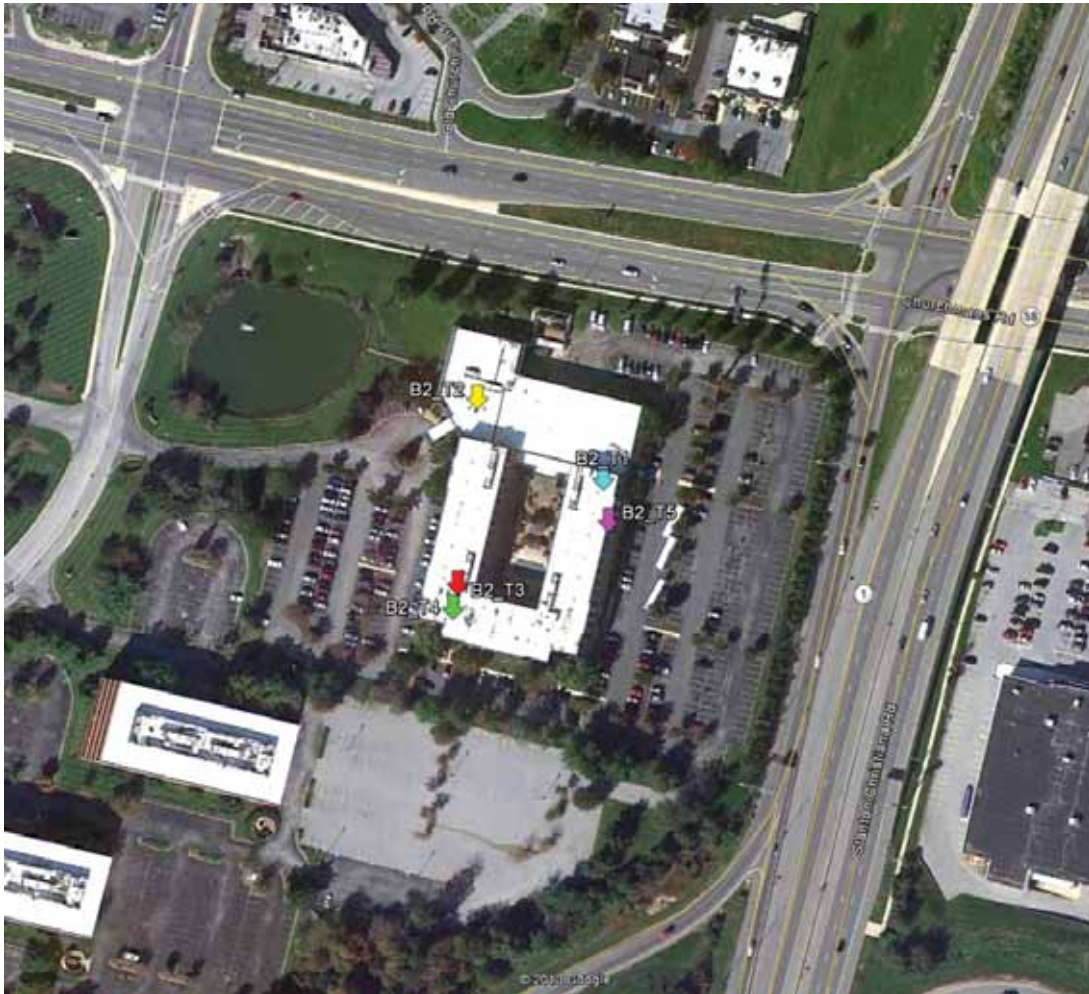
As seen in the Google Earth images in this section, Building 2 is located in a suburban industrial area neighboring similarly sized buildings. A significant amount of space between buildings is a characteristic of this suburban area.

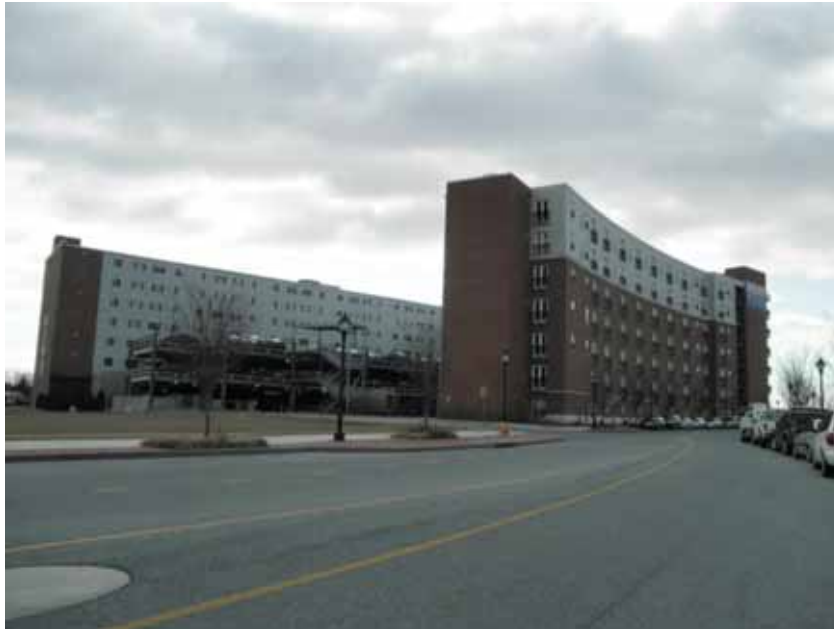
Building 4, Justison Landing, is a seven story concrete and brick building that forms a U shape around a parking structure. It is located at 331 Justison Street in Wilmington, DE.

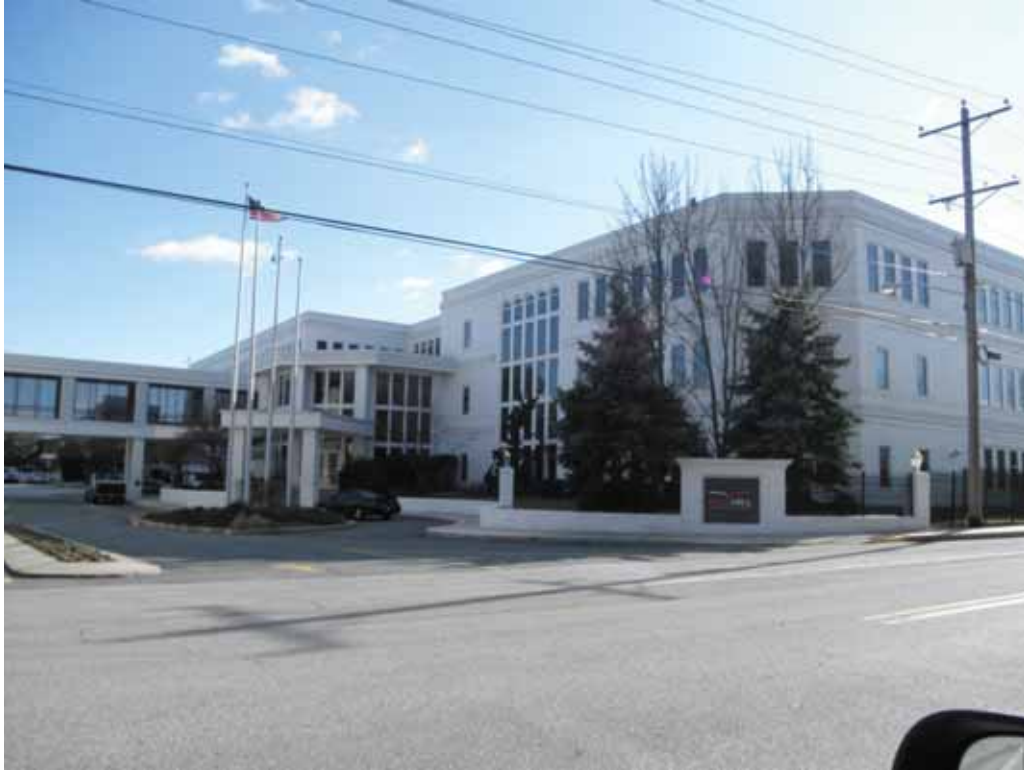
Building 8 is the “Iron Hill” building at 700 Prides Crossings, Newark, DE in Wilmington, DE. It is a 3 story concrete building covering a full street block.

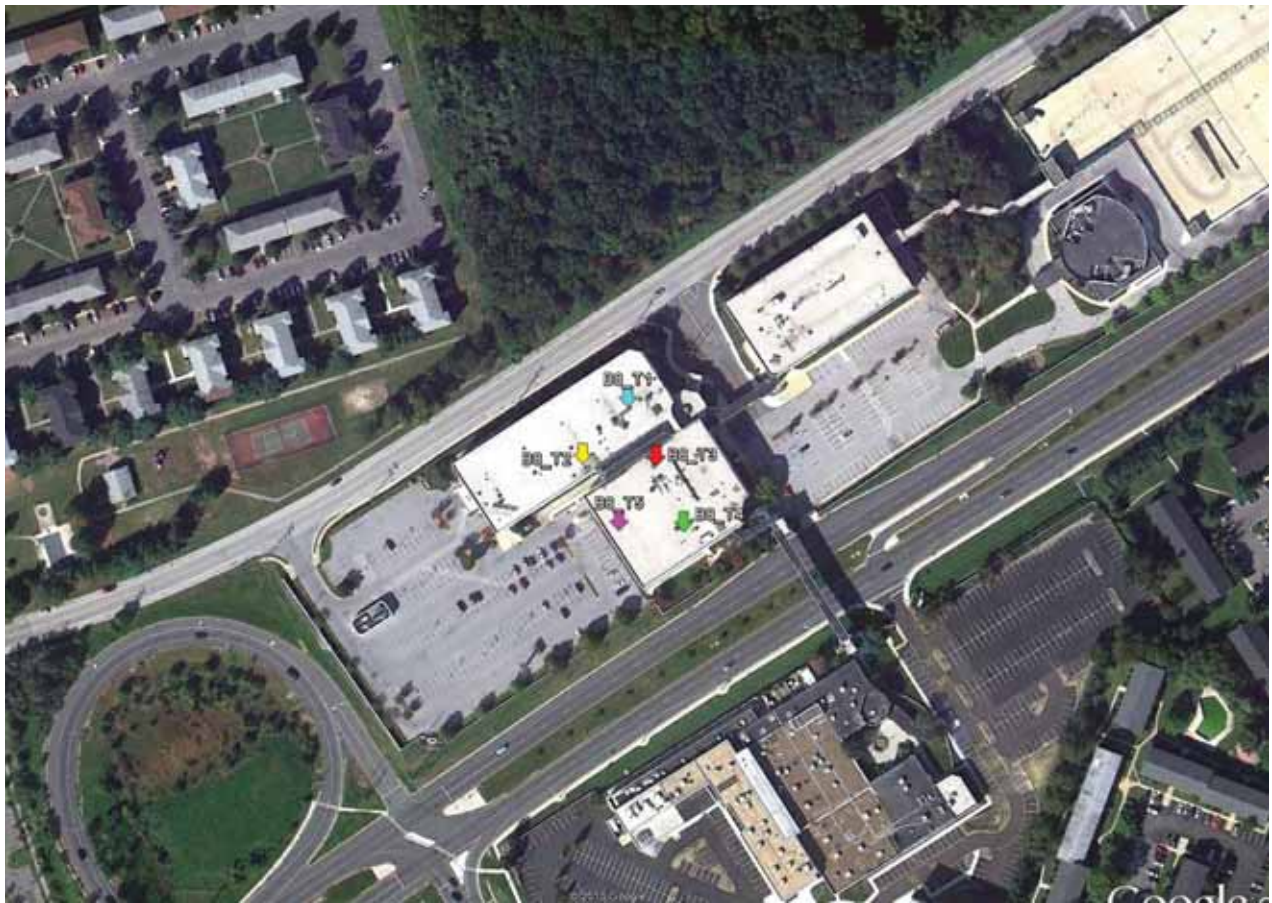
As seen in the Google Earth aerial view, Building 8 has two wings with an atrium in between. The building is in a suburban industrial/residential area. Neighboring buildings include three short structures as well as townhomes.

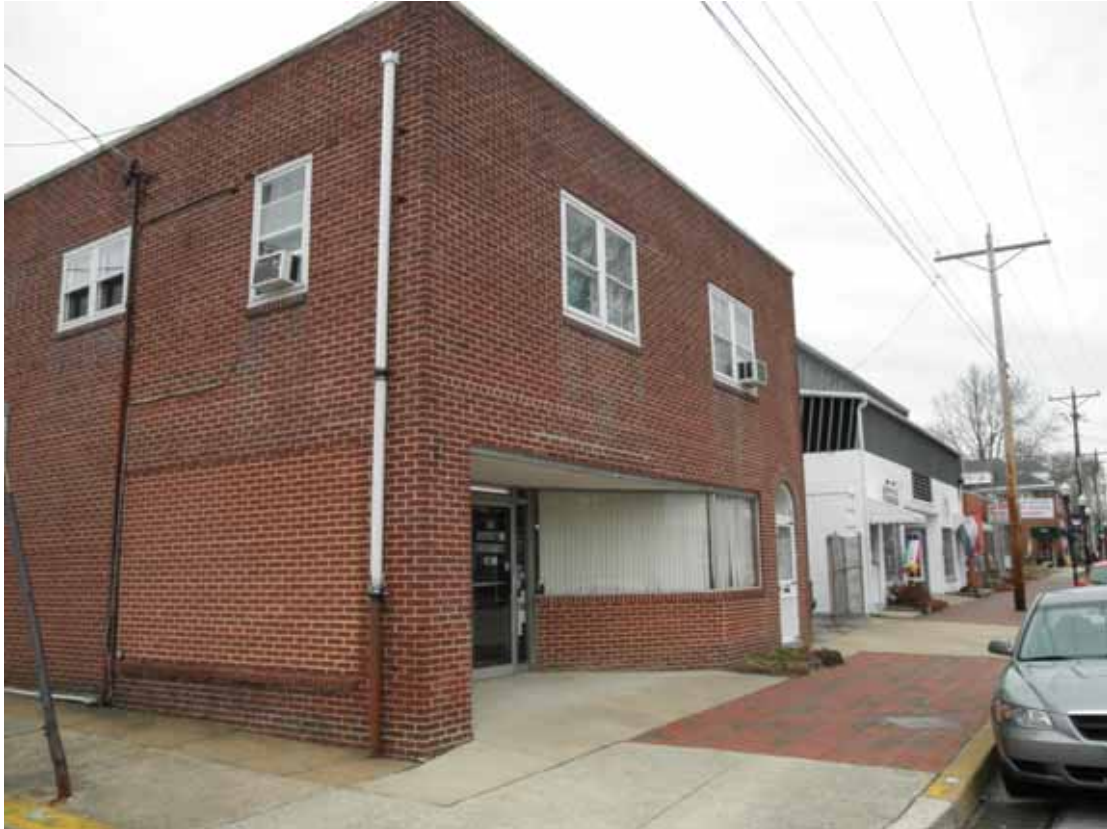
Building 10 is a brick two story office building located in the suburbs of Wilmington at 801 Brandywine.

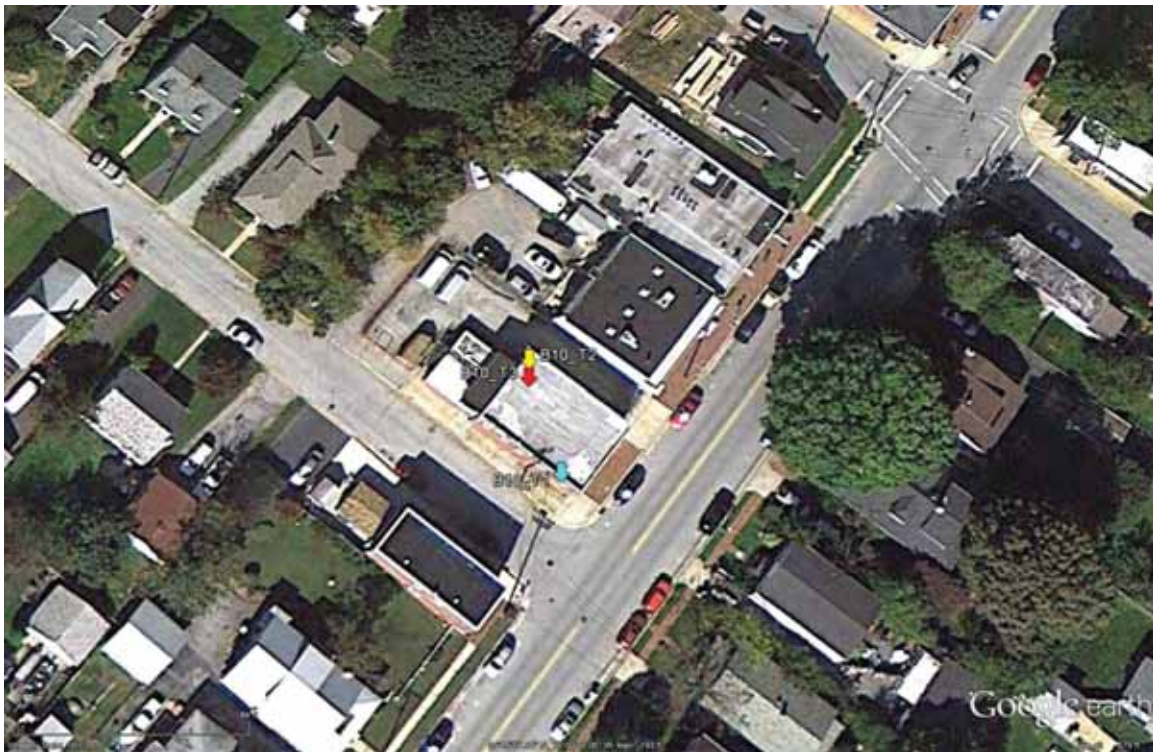
The Google Earth aerial view shows that the building is in a suburban area surrounded by one and two story buildings and homes.
